Proposed OCGT Development

Visual Assessment of Existing Road Pavement

EP Energy Developments

Project number: 60661667

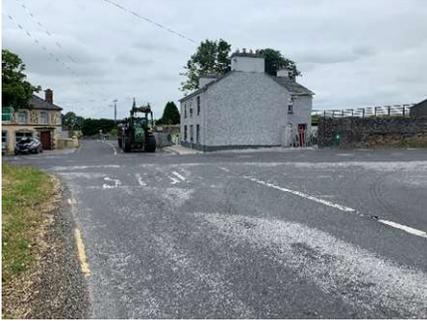
Chainage (km)	Condition Pavement Surface	Image
0.00-0.10	Road markings worn at junction and some oil staining of surfacing Pavement surface in good condition

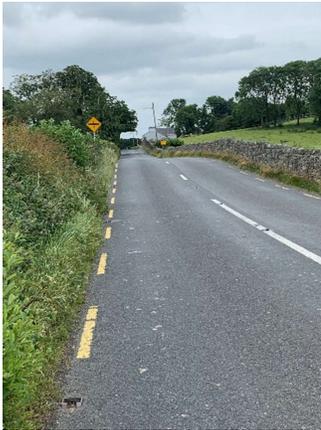
0.10-0.20	Pavement surface in good condition, slight surface deterioration	
0.20-0.30	Pavement surface in good condition, hump in road

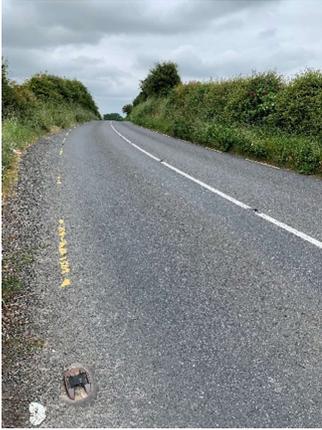
Chainage (km)	Condition Pavement Surface	Image
0.70-0.80	Pavement surface in good condition, slight fatting/ flushing parallel with centre line

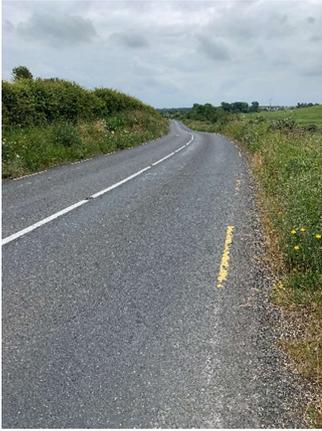
0.80-0.90	Pavement surface in good condition, slight fatting/ fretting parallel with yellow line

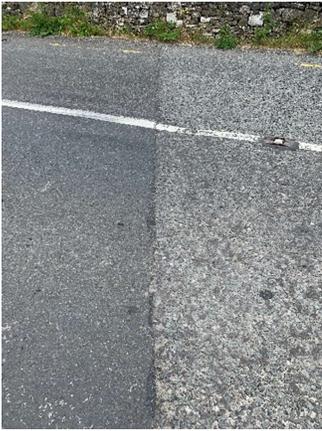
0.90-1.00 0.96	Pavement surface in good condition, slight surface deterioration on approach to bend Joint in Road – change in pavement surface

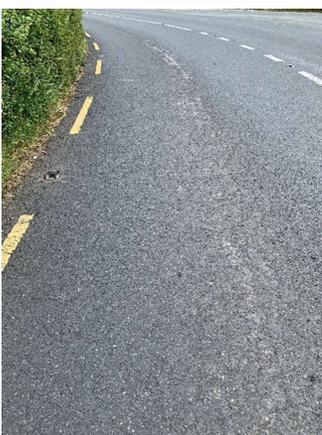
1.15	Joint in the road - change in pavement surface	
1.20-1.30	Pavement surface in good condition, slight surface deterioration	
1.30-1.40	Pavement surface in good condition, slight surface deterioration	
1.40-1.50	Pavement surface in good condition, slight surface deterioration	
1.50-1.60	Pavement surface in good condition, slight surface deterioration	
1.60-1.70	Pavement surface in good condition, slight surface deterioration	
1.70-1.80	Pavement surface in good condition, slight surface deterioration /rutting of surface

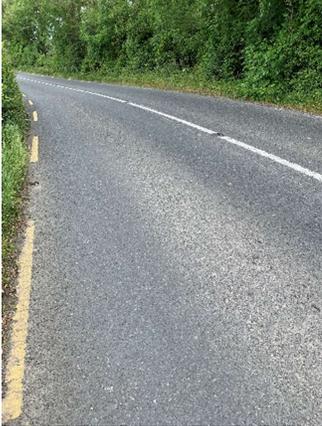
Chainage (km)	Condition Pavement Surface	Image
1.80-1.90	Pavement surface in good condition, surface deterioration at approach to bend

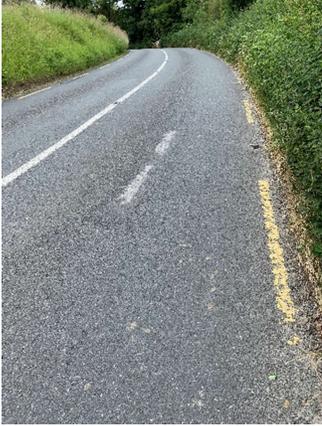
2.00-2.10	Pavement surface in good condition, slight surface deterioration

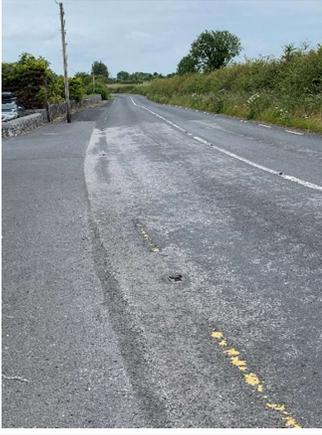
Chainage (km)	Condition Pavement Surface	Image
2.85-2.95	Extensive surface deterioration in front of Hodgins Architectural Glazing premises

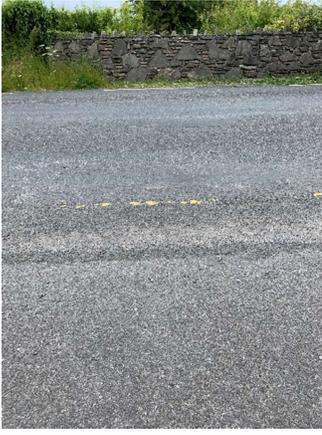
2.95-3.00	Pavement surface in good condition, slight surface deterioration

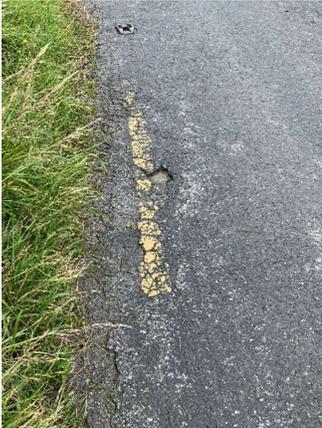
3.03	Deterioration of road edge and pothole Property entrance southbound carriageway

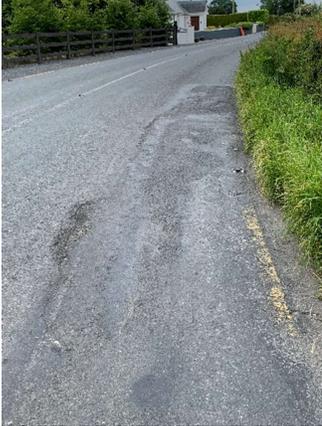
Chainage (km)	Condition Pavement Surface	Image
3.04-3.07	Patch repair, deterioration of road edge and uneven surface

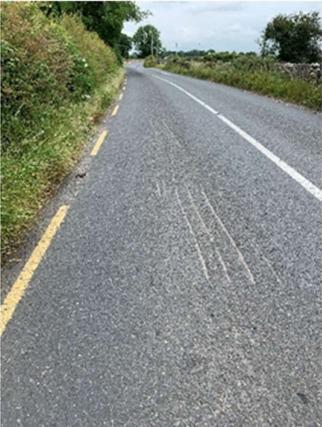
3.35-3.36	Scrape marks in the surfacing	
3.40-3.50	Pavement surface in good condition	
3.50-3.60	Pavement surface in good condition, slight surface deterioration	
3.60-3.70	Pavement surface in good condition	
3.70-3.80	Pavement surface in good condition, slight surface deterioration	
3.75	Scrape marks circa 1m long

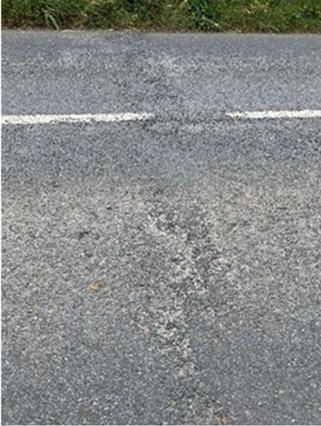
3.83	Slight deterioration in pavement surface across entire road	
3.90-4.00	Pavement surface in good condition, slight surface deterioration	
4.00-4.10	Pavement surface in good condition, slight surface deterioration	
4.10-4.20	Pavement surface in good condition, slight surface deterioration	
4.20-4.30	Wearing of surface opposite junction

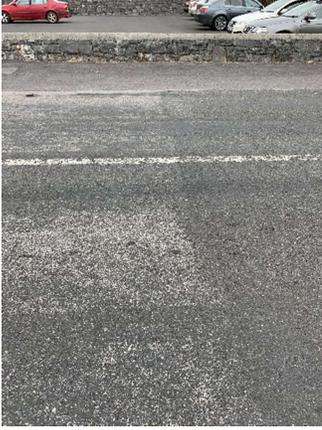
2.85-2.95	Extensive deterioration pavement surface in front of Hodgins Architectural Glazing premises

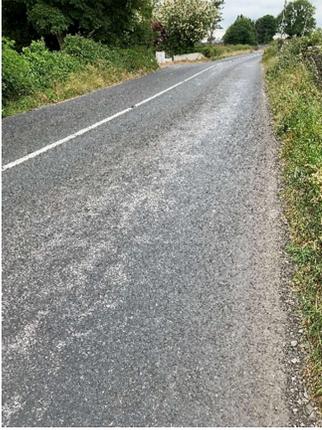
3.40-3.50 3.47-3.53	Pavement surface in reasonable condition Slightly more extensive surface deterioration

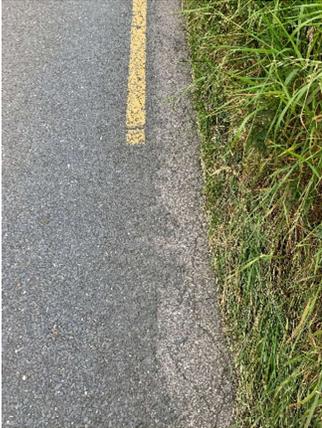
Chainage (km)	Condition Pavement Surface	Image
3.60-3.70	Pavement surface in good condition	
3.70-3.80	Pavement surface in good condition, slight surface deterioration - cracking along road edge

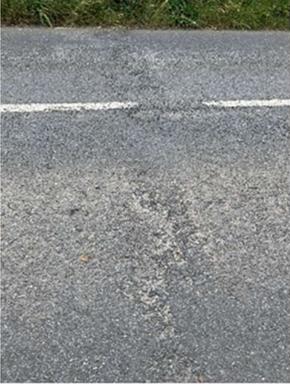
3.80-3.90	Pavement surface in good condition, slight wearing of surface	
3.83	Slight deterioration in pavement surface across entire road

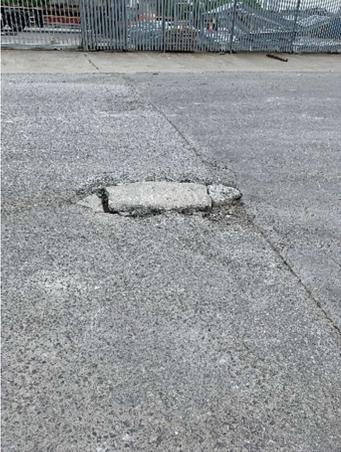
Chainage	Condition Pavement Surface	Image
0.00-0.01	Pavement surface in good condition	
0.01-0.20	Pavement surface in good condition	
0.20-entrance	Cracking and potholing around joint Surfacing appears to comprise a layer of asphalt / macadam over a concrete road surface

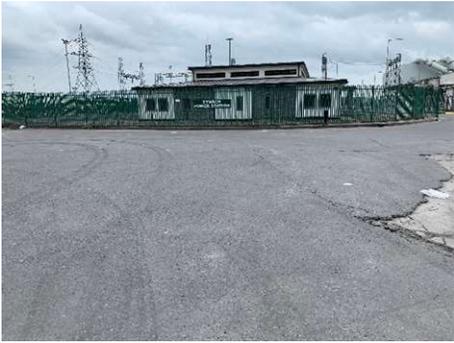
Edge surfacing ragged

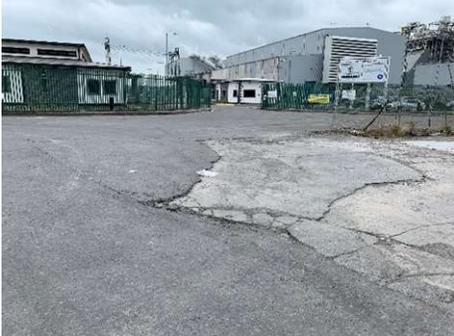
Edge surfacing ragged Surfacing appears to comprise a layer of asphalt / macadam over a concrete road surface
