Appendix 14G  
Bridge Condition Survey

# Structures Visual Inspection Report

Project Tynagh

Project reference: Project Tynagh  
Project number: 60661667

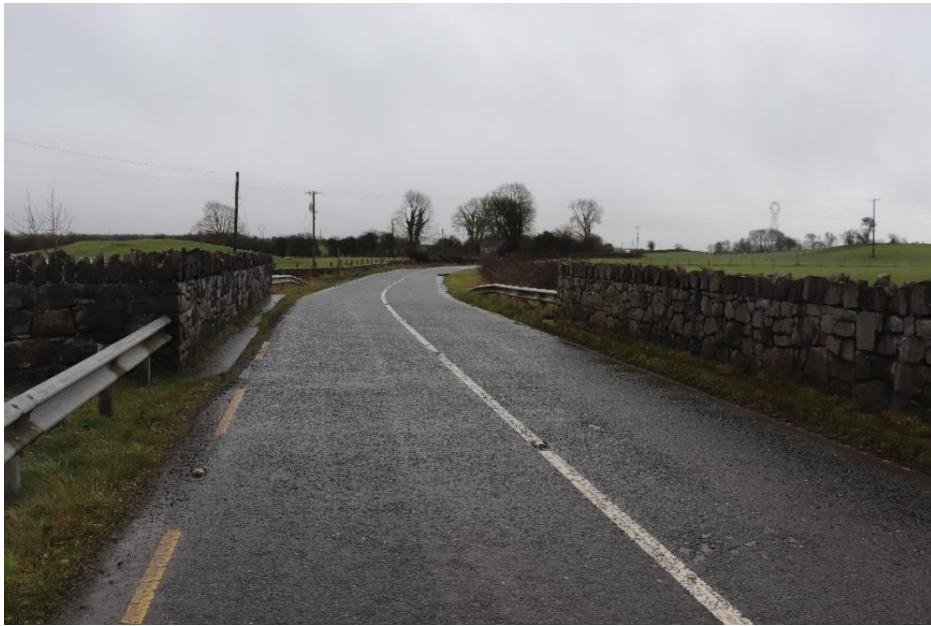
Component No.	Component	Condition Rating	Maintenance Required	Defect Type	Photos	Comments	
1	Bridge Surface	0	Y	-	Y	Surfacing over bridge structure was found to be in good condition with no defects noted, see Figure 7 in Appendix A.	
2	Expansion joint	N/A	N/A	N/A	N/A	Not applicable to this structure in Appendix A.	
3	Footway / Median	0	Y	-	Y	No defects were noted to the concrete verges over the structure from inspection, see Figure 7 and Figure 8 in Appendix A.	
4	Parapet/safety Barrier	2	Y	32 45	Y	Inspection of parapets was undertaken from the bridge deck and riverbed on east side of the bridge. Minor defects noticed including loss of masonry facing and cracking of the pointing. A number of stalactites with staining have formed on the parapet edge beam. See Figure 8, Figure 17, Figure 18 and Figure 19 in Appendix A.	
5	Embankments / Revetments	2	Y	26	Y	Timber post and wire fencing has fallen on both the north and south embankments on the east side of the bridge. A large PVC pipe was lying on the south east embankment and extending into the river. See Figure 15, Figure 20 and Figure 21 in Appendix A.

**Figure 7 – Surfacing**

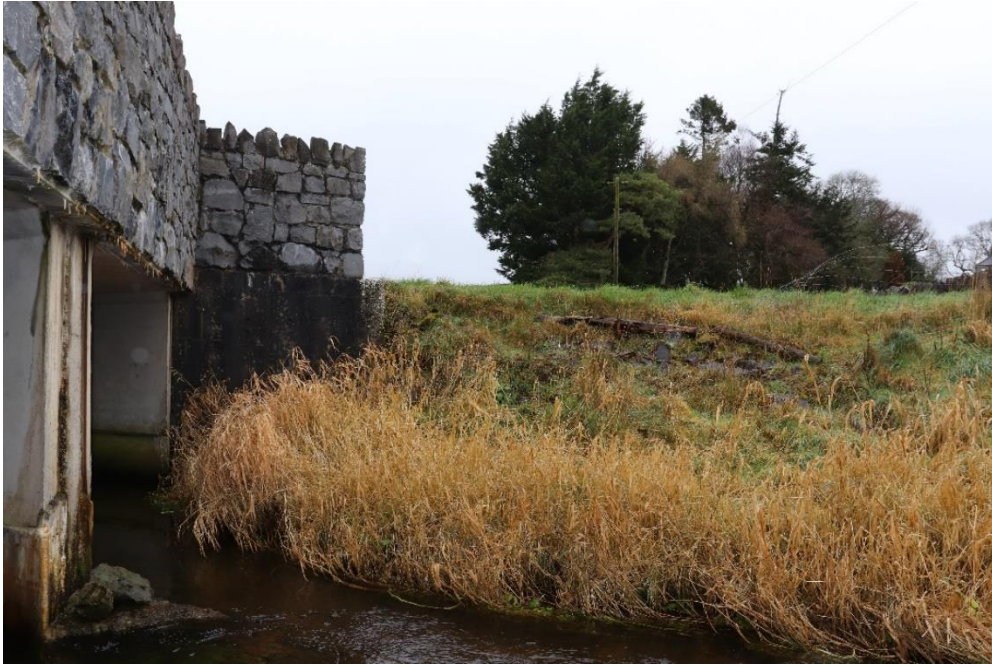
Component No.	Component	Condition Rating	Maintenance Required	Defect Type	Photos	Comments
6	Wingwalls / Spandrel Walls / Retaining Walls	0	Y	-	Y	Wing walls to structure were found to be in good condition. See Figure 15 and Figure 16 in Appendix A.
7	Abutments	2	Y	12 17 20 23 35	Y	South Abutment had visible structural damage at the joint with the wingwall. In addition, loss of rubber filler has occurred at the horizontal joint in the portal leg. Minor spalling and structural damage noted on the north abutment leg, although no visible rebar. There is a noticeable difference in the south abutment leg between the eastern and western sides of the vertical joint. See Figure 22 to Figure 27 in Appendix A.
8	Piers	2	Y	10 13 23	Y	Minor vertical cracking is present on the extreme east end of the north pier. Some minor concrete loss on the south pier. Heavy leaching with rusting/carbonation indicators (red/brownish colour) were noted in a number of areas on the piers, concentrated around gaps in the rubber filler in the portal legs and at the vertical joints between the portal units. There is a noticeable difference in the north pier between the eastern and western sides of the vertical joint. See Figure 28 to Figure 31 in Appendix A.

**Figure 15 - North East Wingwall and Embankment**

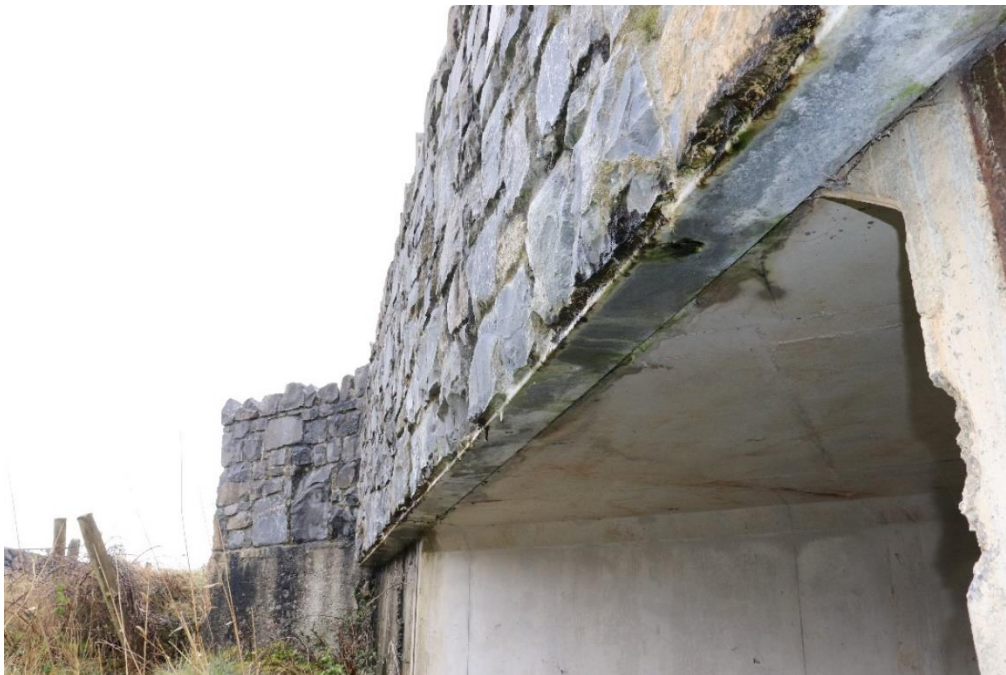
**Figure 16 - South East Wingwall and Parapet Edge Beam**

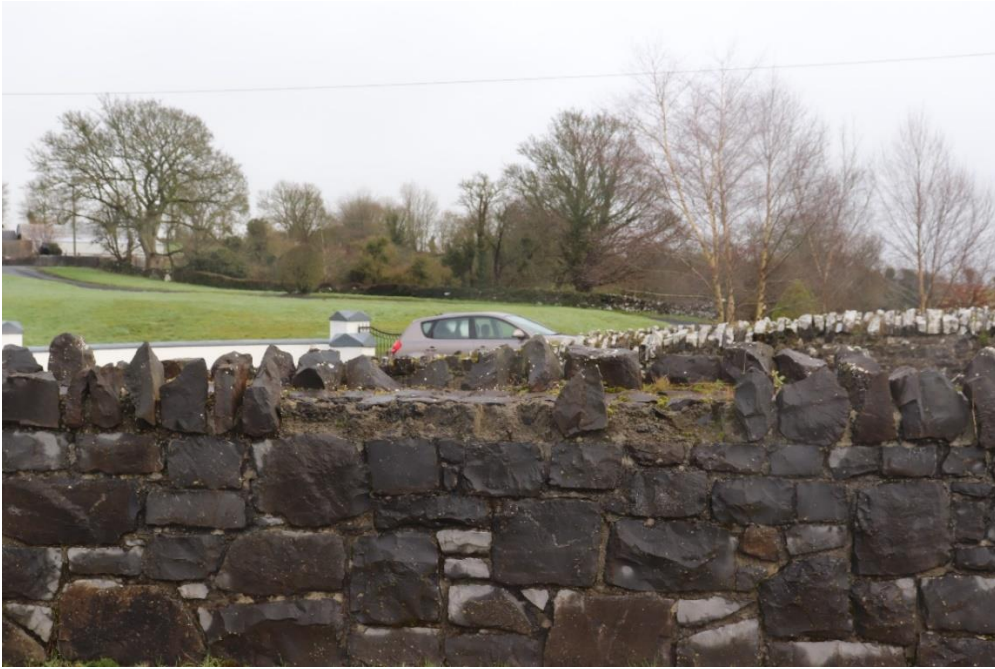
Figure 17 - Loss of Masonry Facing

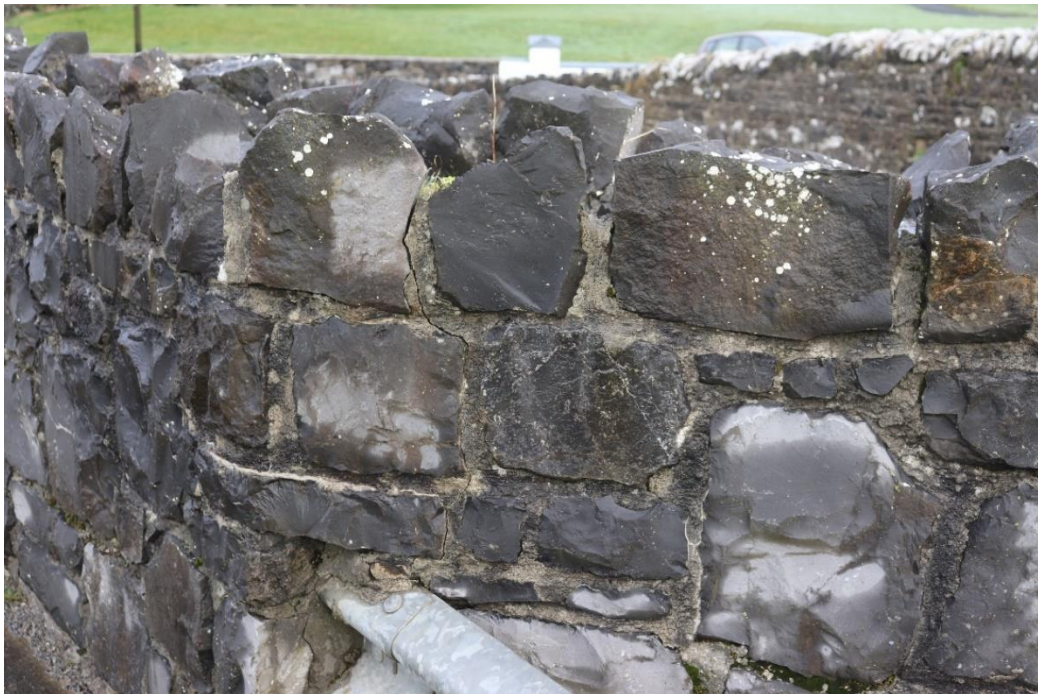
Figure 18 - Cracking of Masonry Pointing

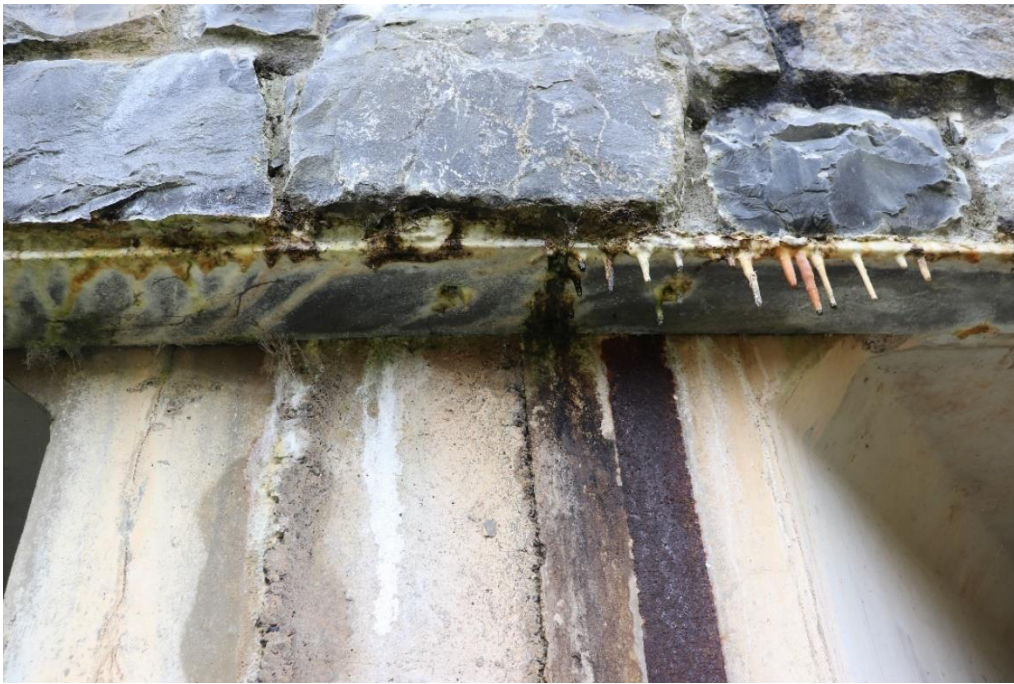
**Figure 19 - Stalactites and Staining on Parapet Edge Beam**

Maintenance Actions
From inspection of the structure it is advised that the following maintenance actions are undertaken; - Repair rubber filler along horizontal joint in the portal legs; - Repair/replace the timber post and wired fencing along the crest of the river embankment; and - Removal of calcite build-up from parapets and joints.
Inspector's Comments
Inspection of the top surface of the bridge and the parapets was carried out from the bridge deck. Inspection of the substructure elements was carried out from the riverbed and embankments on the east side of the bridge. Due to high water levels, a heavy flow in the river and protective fencing, access to the embankments and riverbed on the west side of the bridge was not possible. From the limited visibility granted from the road level the condition at the west side of the bridge appeared similar to the east side. From inspection the structure appeared to be in good condition with no visible signs of significant distress to the structure or its primary elements.

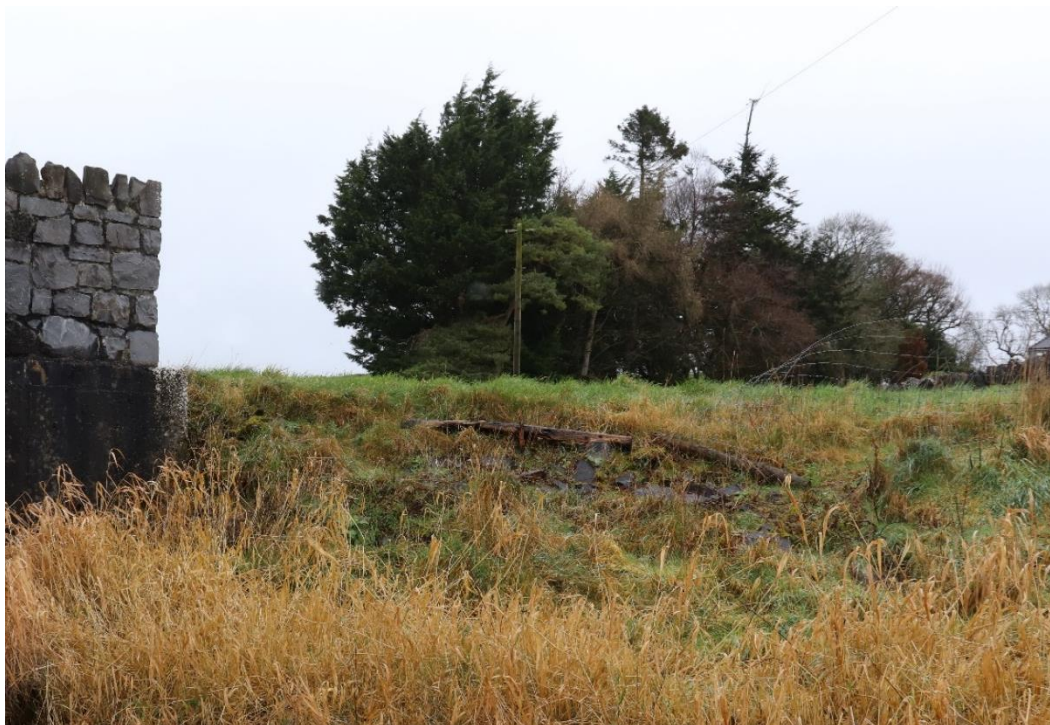
**Figure 20 - Fallen Timber Post and Mesh Fence**

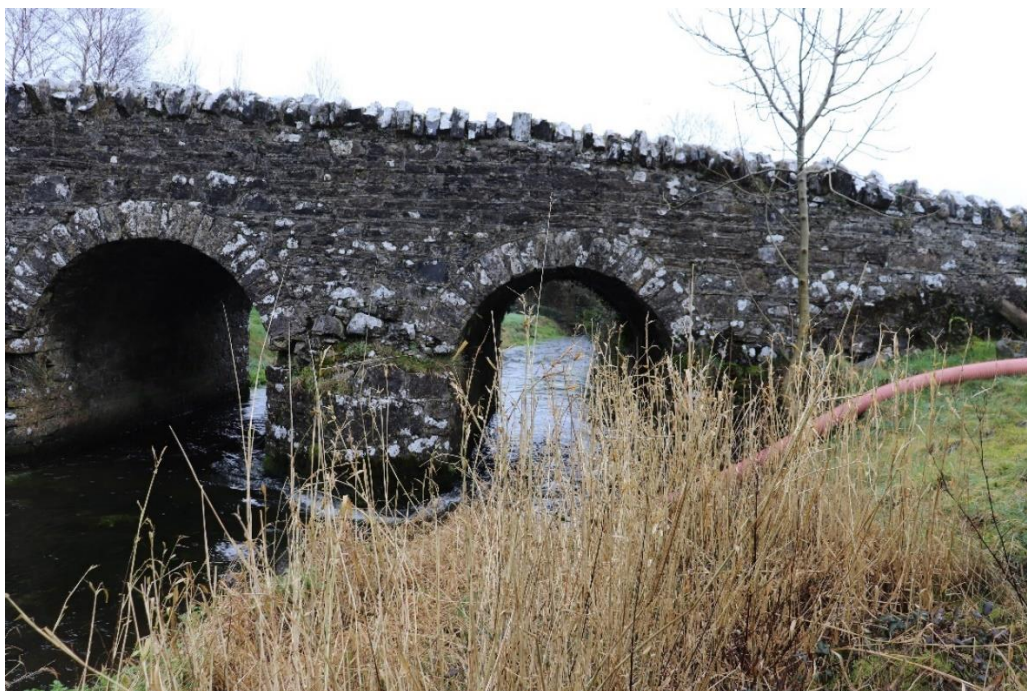
**Figure 21 - Pipe on River Embankment Downstream of ST01 (Masonry Arch Bridge visible here is parallel to ST01 and not included in this inspection)**

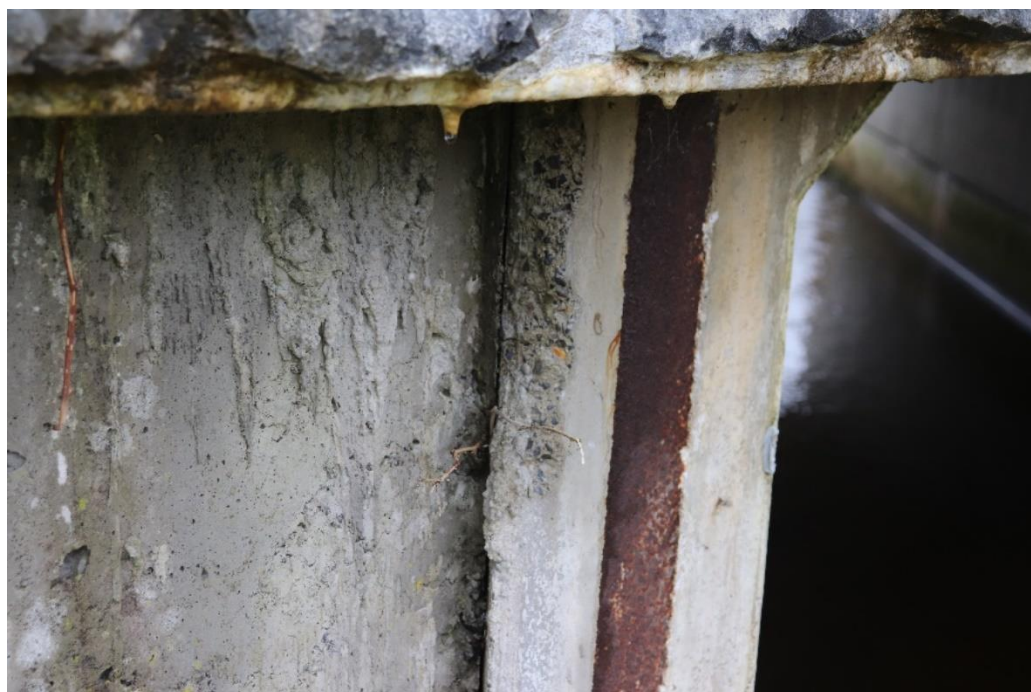
**Figure 22 - Damage and Concrete Loss to South Abutment**

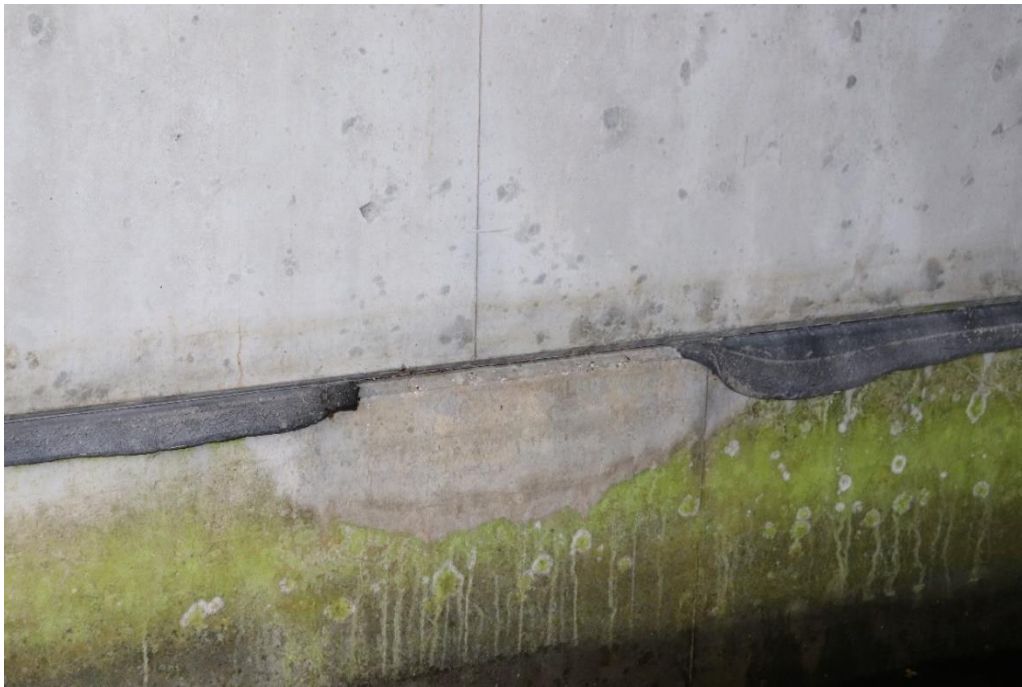
**Figure 23 - South Abutment Joint Filler Loss**

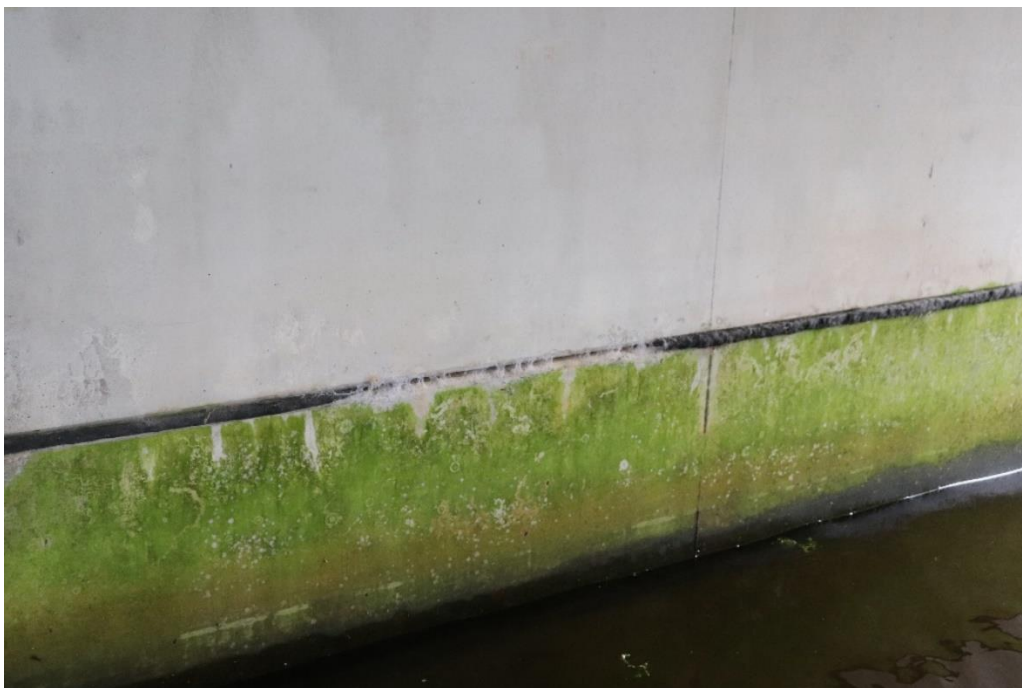
**Figure 24 - South Abutment Additional Joint Filler Loss**

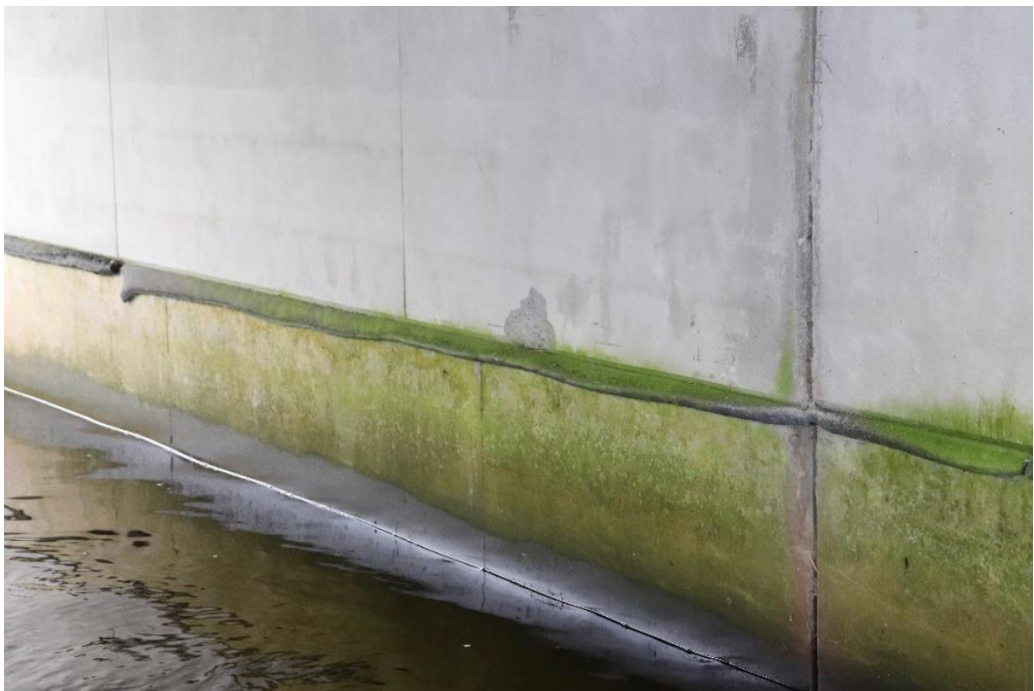
**Figure 25 - Spalling of Concrete on North Abutment**

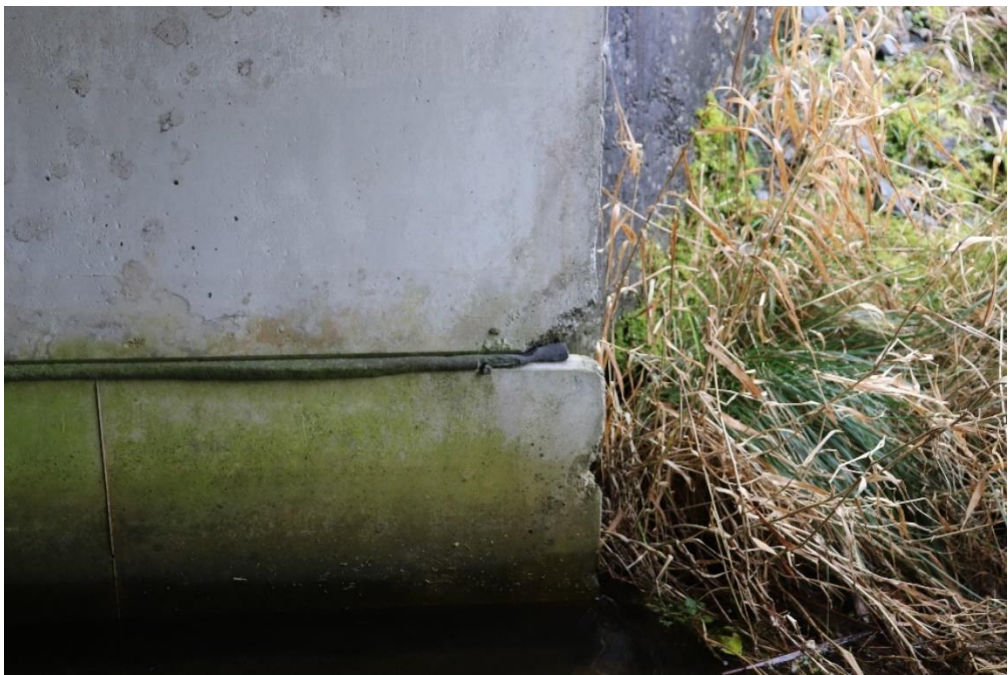
**Figure 26 - Damage and Concrete Loss to North Abutment**

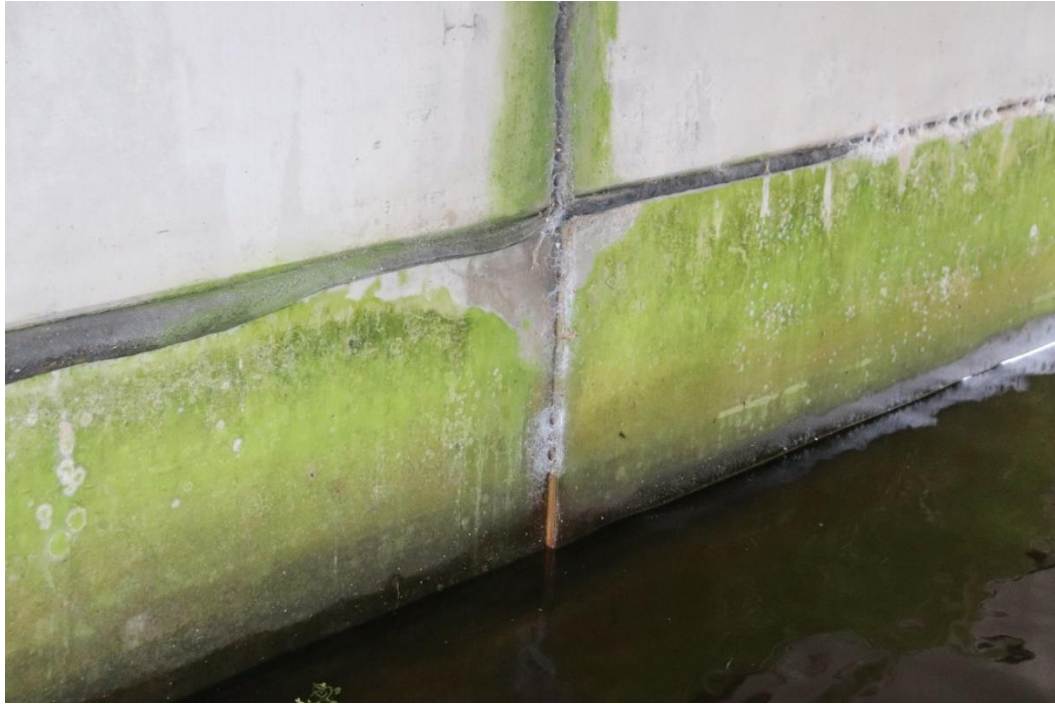
**Figure 27 - Position Difference in South Abutment at Vertical Joint**

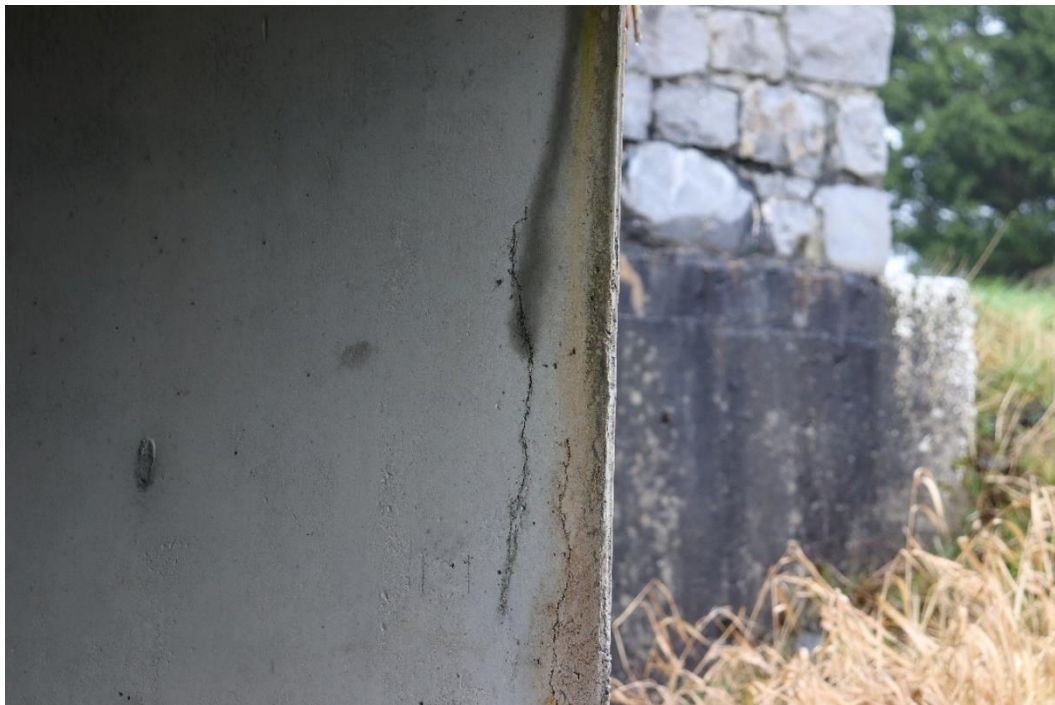
**Figure 28 - Cracking in North Pier**

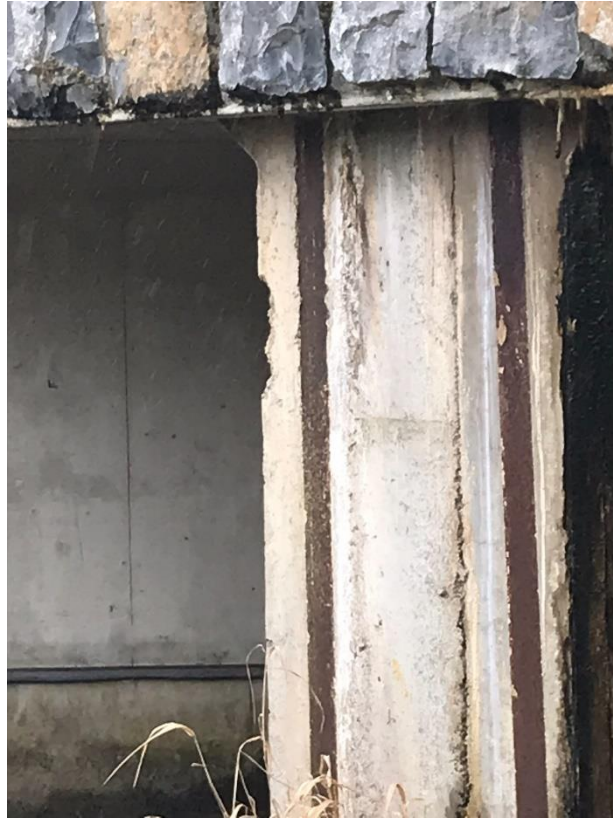
**Figure 29 - Damage and Concrete Loss to South Pier**

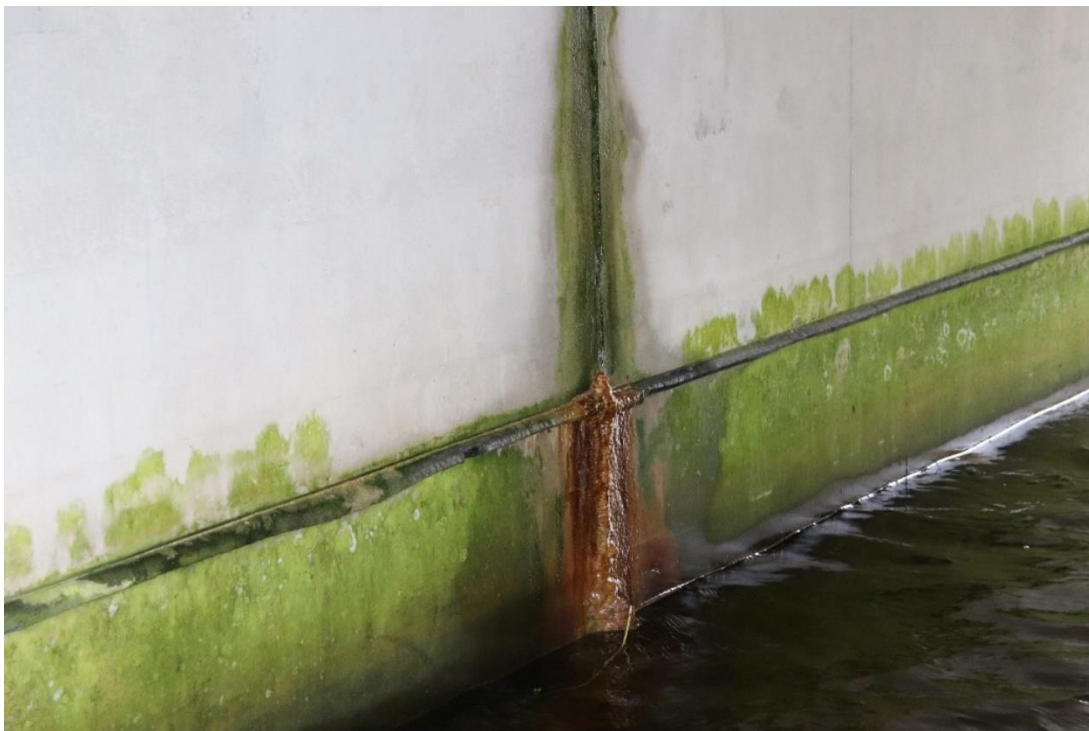
**Figure 30 - Heavy Leaching and Material Build-up on North Pier**

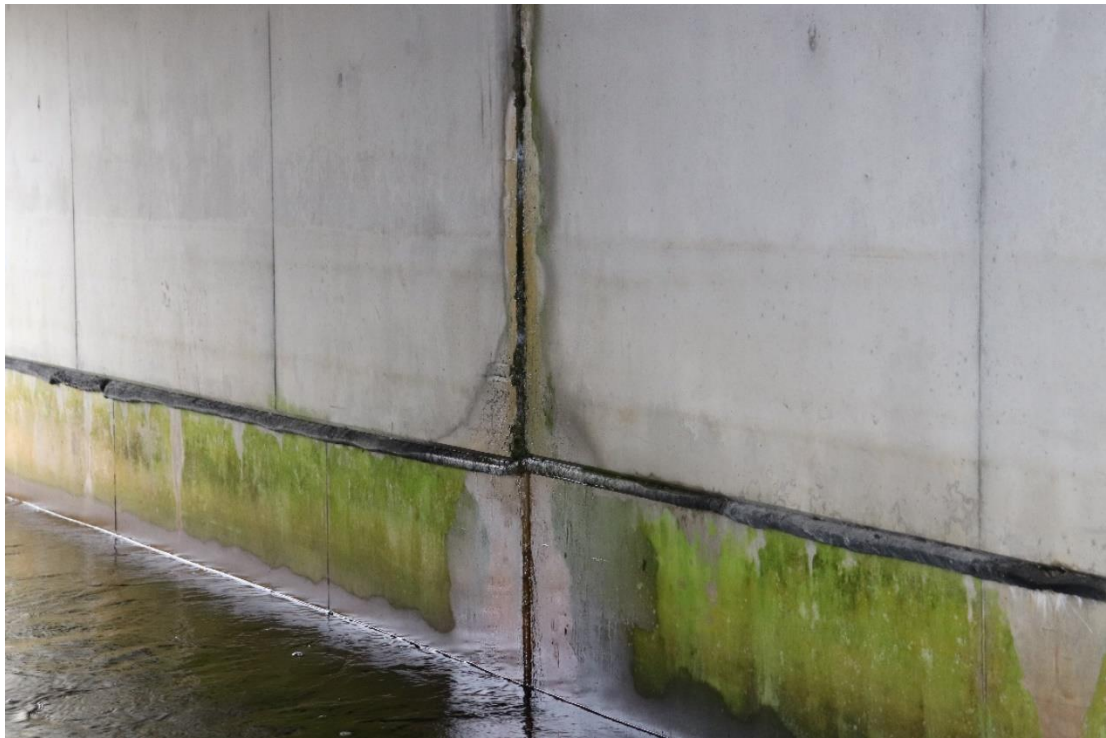
**Figure 31 - Position Difference in North Pier at Vertical Joint**

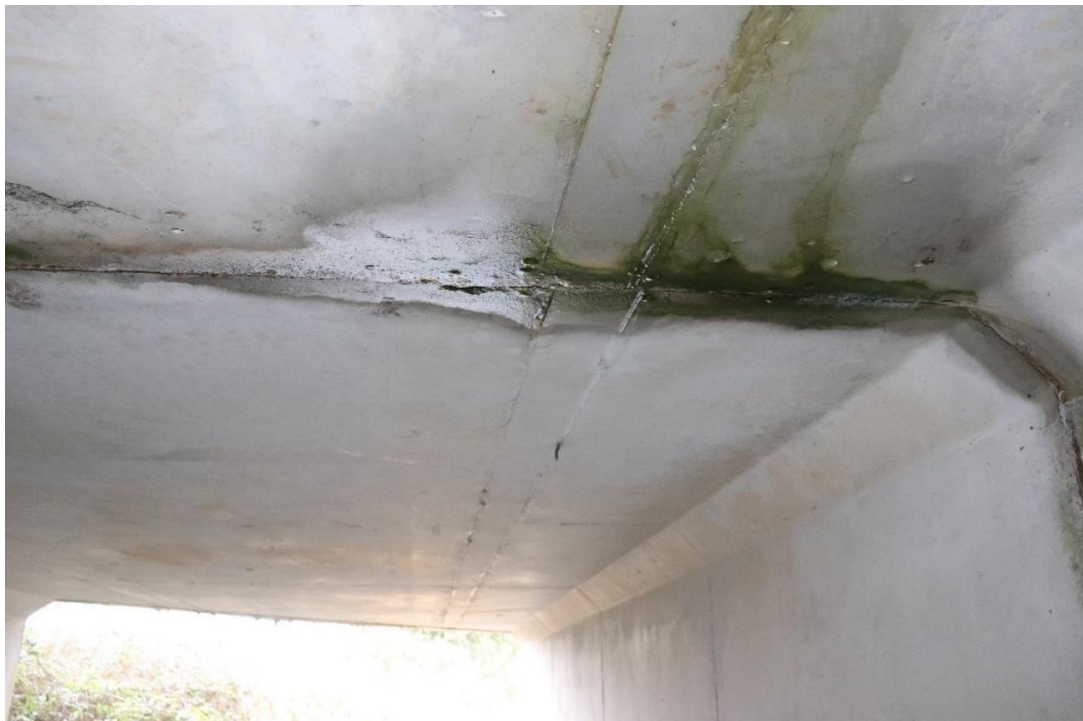
9	Bearings	N/A	N/A	N/A	N/A	Not applicable to this structure.
10	Deck/Slab	1	Y	17 22	Y	No defects noted to the deck soffit of the structure. It was visible from the riverbed that water can seep through the deck at the main joint location, leaching onto the soffit causing staining. One very minor area of concrete loss was noted. See Figure 32 and Figure 33 in Appendix A.
11	Beams / Girders / Transverse Beams	N/A	N/A	N/A	N/A	Not applicable to this structure.
12	Riverbed	1	Y	26 36	Y	Riverbed was generally in good condition. Immediately upstream and downstream of the bridge, vegetation build-up is restricting the channel capacity. Silt build-up was noticed in the north and south spans. See Figure 5 and Figure 6 in Appendix A.
13	Other Elements	0	Y	12 35 38	Y	Vertical steel strips are visible in the end elevation of all portal legs which are now heavily rusted. Their purpose is unknown. Concrete cover of the steel strip on the north abutment has spalled from the surface. See Figure 11, Figure 12 and Figure 34 in Appendix A.

**Figure 32 - Leaching and Water Seepage on Soffit of South Span**

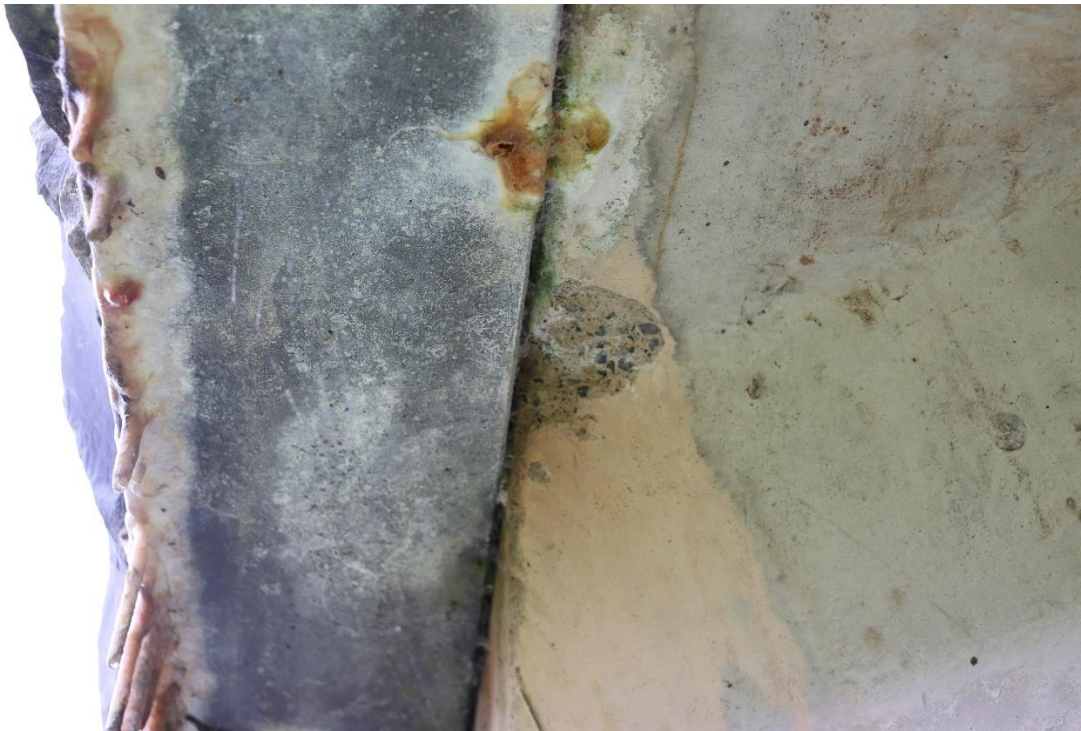
**Figure 33 - Damage and Concrete Loss to Soffit of North Span**

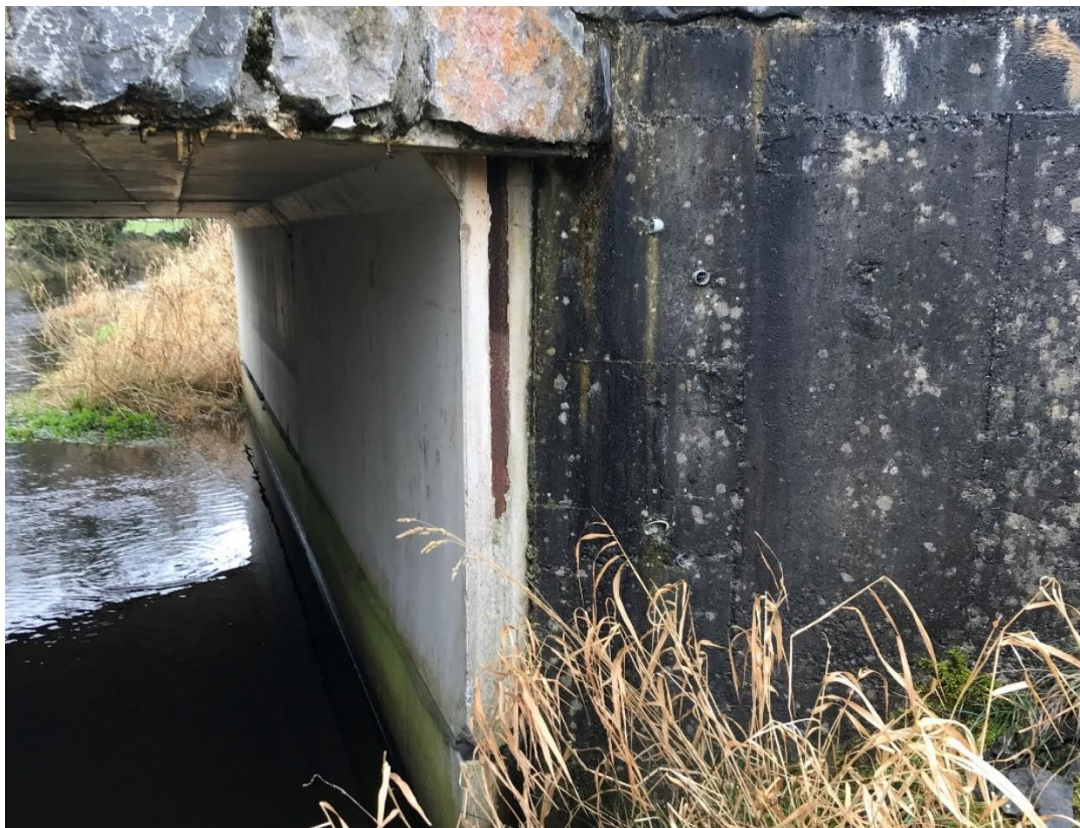
**Figure 34 - Concrete Spalling around Corroded Steel Strips**

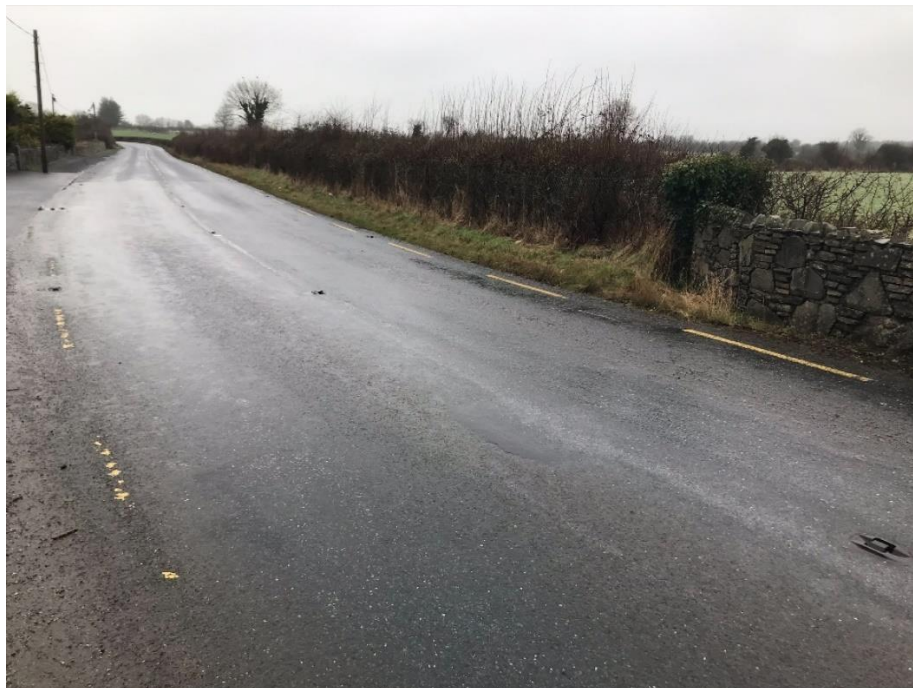
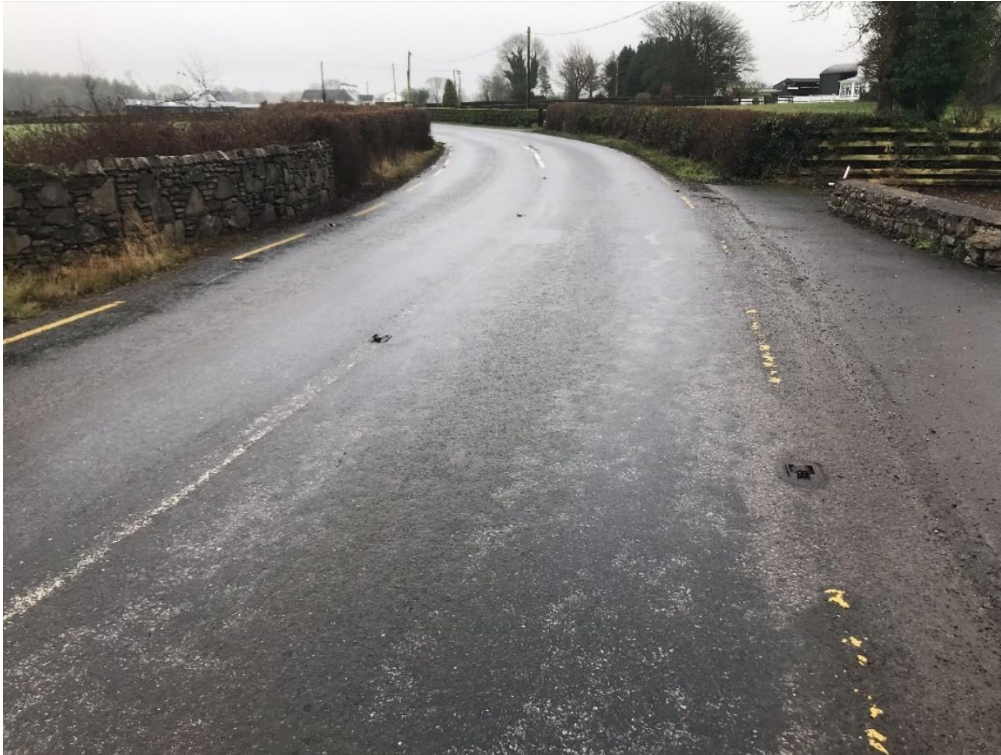
Inspection Report						
Structure Information			Structure Position (ITM)			
Structure Name:	ST02 – Masonry Culvert		Easting:	573,635.000		
Structure Ref:	Unknown		Northing:	713,893.000		
Inspection Information						
Inspector Initials:	CM/RM		Date:	08/02/2022		
Weather:	Cloudy/Rain		Temperature:	10°C		
Structural Form						
Structure Geometric Information			Number of Spans	2 span		
			Total Span Length	2.43m (Internal Culvert Spans including Central Pier)		
			Structure Width	9.17m		
Superstructure			Type	Double Culvert		
			Material	Masonry Stone		
Substructure			Abutment:	Type	Abutment wall & wing walls	
				Material	Concrete and Masonry Stone	
				Foundation	Unknown	
			Pier:	Type	Central Pier	
				Material	Concrete	
				Foundation	Unknown	
Recorded Structural Condition						
Component No.	Component	Condition Rating	Maintenance Required	Defect Type	Photos	Comments
1	Bridge Surface	0	N	-	Y	Surfacing over structure was found to be in good condition with no defects noted, see Figure 36 and Figure 37 in Appendix B.

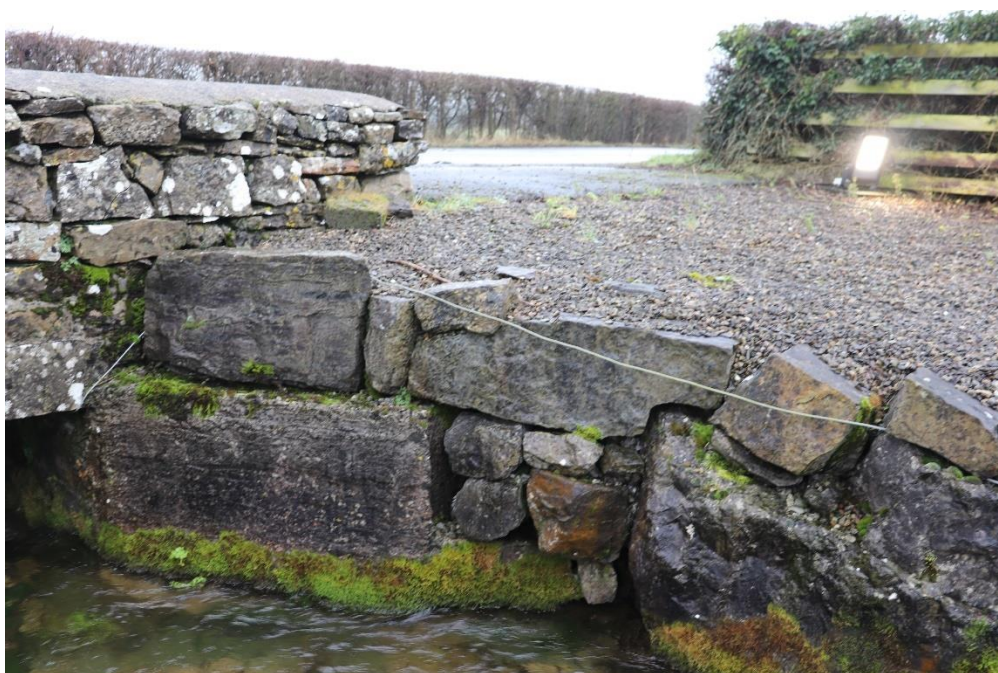
**Figure 40 – Southwest Wingwall and Abutment**

7	Abutments	2	N	26	Y	Abutments to the structure were found to be in good condition with some vegetation growth, see Figure 40 and Figure 48 in Appendix B. Access to the abutments on the east was limited due to excessive vegetation.
8	Piers	0	N	-	Y	Central Pier was found to be in good condition with no defects noted, see Figure 41 in Appendix B.
9	Bearings	N/A	N/A	N/A	N/A	Not applicable to this structure.
10	Deck/Slab	0	N	-	N	No defects noted to the deck soffit of the structure. Due to the limited clearance within the structure, <1m, inspection of the soffit was not possible.
11	Beams / Girders / Transverse Beams	0	N	-	Y	Transverse capping stones and beams were found to be in good condition with no defects noted. See Figure 42 and Figure 44 in Appendix B.
12	Riverbed	2	Y	26 36	Y	Debris and silt build-up on the northeast of the structure. Otherwise, the riverbed is in good condition. See Figure 46 and Figure 49 in Appendix B.

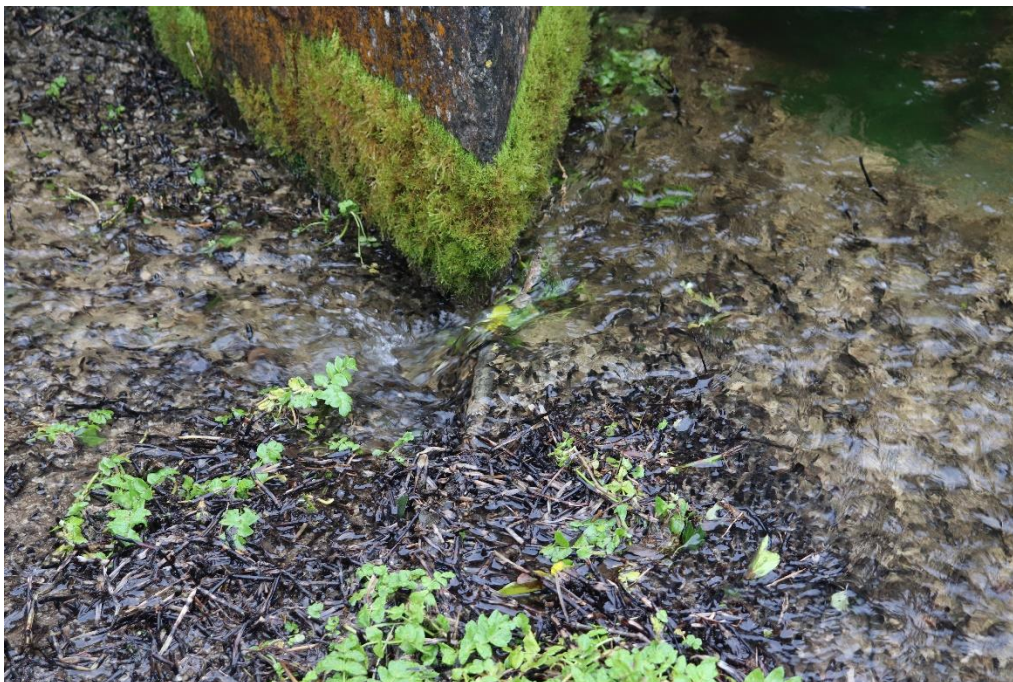
**Figure 47 – Service Duct**

13	Other Elements	0	N	-	Y	A service duct runs through the southern culvert. No defects were noted to this service duct. See Figure 47 in Appendix B.
14	Structure in General	0	Y	-	Y	Structure was found to be in good condition with some defects to elements noted. No defects were noted to ancillary elements which would indicate that the primary elements of the structure were in distress.
<b>Maintenance Actions</b>						
<p>From inspection of the structure, it is advised that the following maintenance actions are undertaken;</p> <ul style="list-style-type: none"> <li>- Remove excess vegetation from the structure; and</li> <li>- Remove debris from the riverbed.</li> </ul>

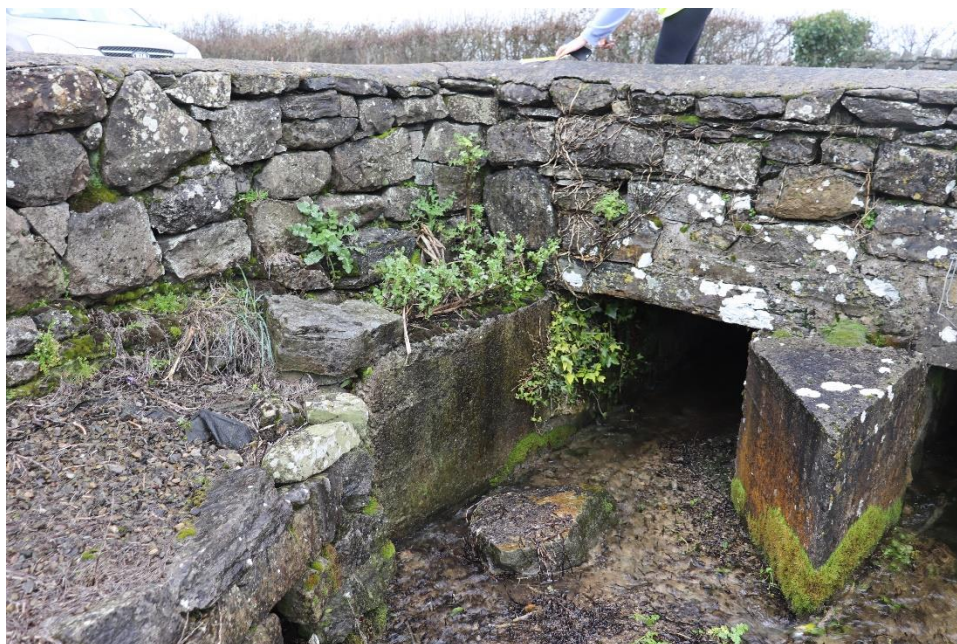
Component No.	Component	Condition Rating	Maintenance Required	Defect Type	Photos	Comments
4	Parapet/safety Barrier	0	N	26	Y	Inspection of parapets was undertaken from the bridge deck. Heavy vegetation was present over the northern portion of the east parapet. If left unmaintained could damage the masonry facing. No major defects were noted to the parapets over the structure, see Figure 38 and Figure 39 in Appendix B for general condition. However, the west parapet height (450mm) is too low for pedestrians and should be increased to 1.25m in accordance with DN-REQ-03034, The Design of Road Restraint Systems (Vehicle and Pedestrian) for Roads and Bridges.
5	Embankments / Revetments	0	N	26	N	No defects noted to the east or west embankment or revetments of the structure, however, access to the east embankment was limited due to the excessive vegetation.
6	Wingwalls / Spandrel Walls / Retaining Walls	2	N	26	Y	Wing walls of the structure were found to be in good condition with some vegetation growth, see Figure 40 and Figure 48 in Appendix B. Access to the wingwalls on the east was limited due to excessive vegetation.

Figure 48 – Northwest Wingwall and Abutment with Vegetation Growth

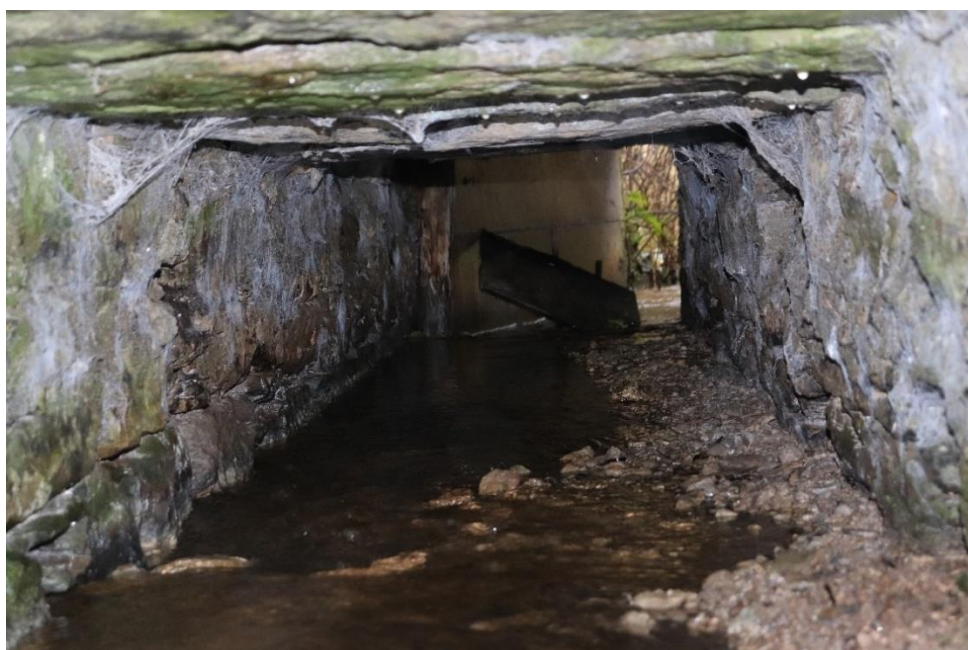
Figure 49 – Debris and Silt Build-up in Riverbed
