Appendix 14G  
Bridge Condition Survey

# Structures Visual Inspection Report

Project Tynagh

Project reference: Project Tynagh  
Project number: 60661667

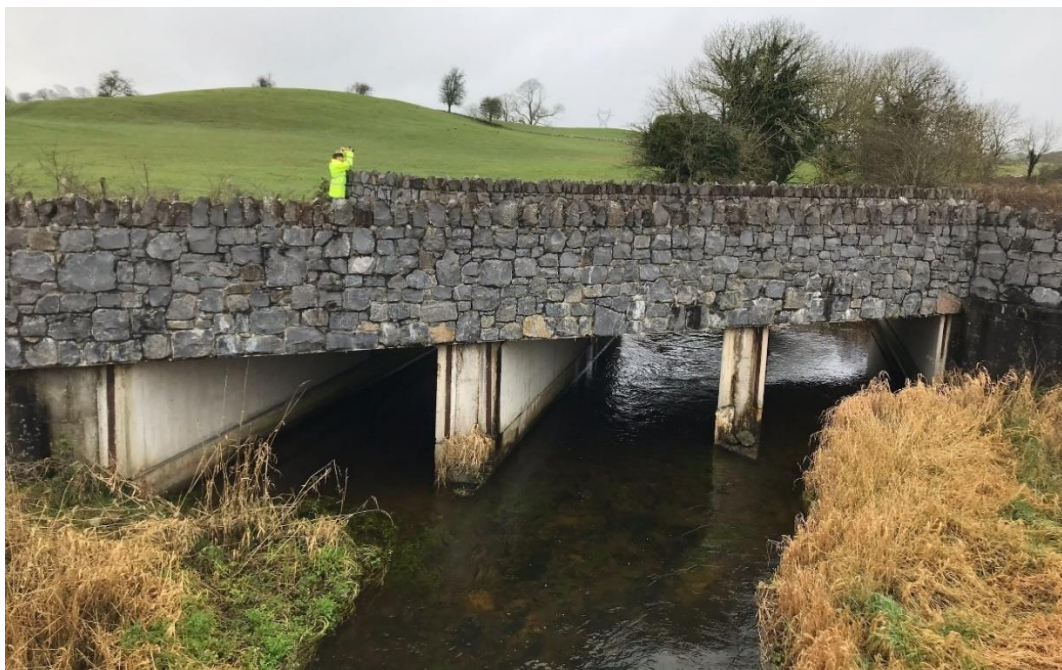
Figure 5 – East Elevation

14	Structure in General	2	Y	-	-	Structure was found to be in good condition with some minor defects to elements noted. No major defects were noted to ancillary elements which would indicate that the primary elements of the structure were in distress. See Figure 5 to Figure 16 in Appendix A for general structure photographs.

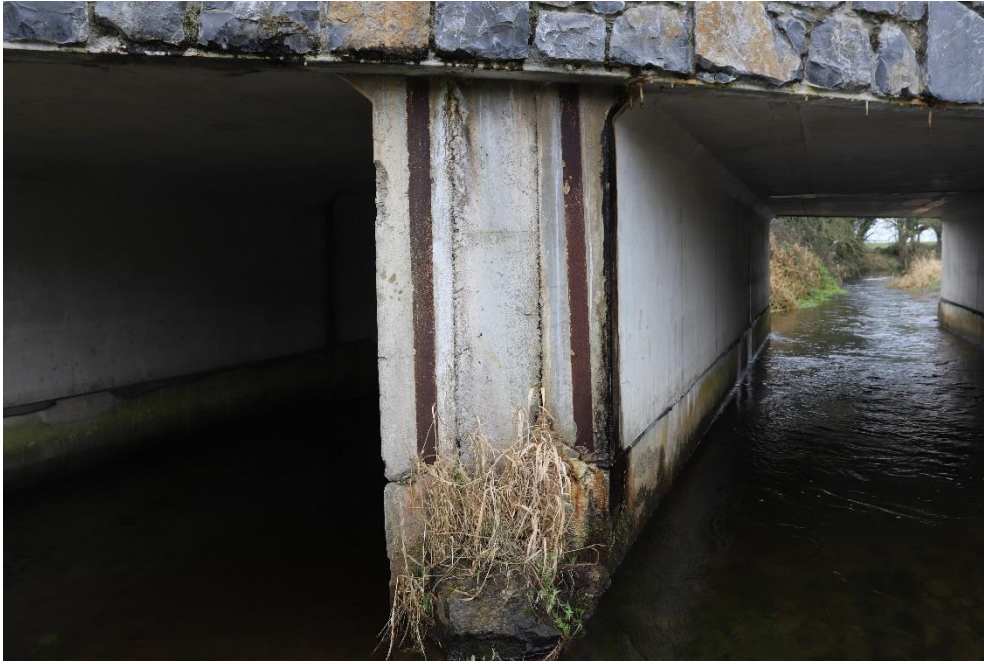
**Figure 11 - South Pier**

9	Bearings	N/A	N/A	N/A	N/A	Not applicable to this structure.
10	Deck/Slab	1	Y	17 22	Y	No defects noted to the deck soffit of the structure. It was visible from the riverbed that water can seep through the deck at the main joint location, leaching onto the soffit causing staining. One very minor area of concrete loss was noted. See Figure 32 and Figure 33 in Appendix A.
11	Beams / Girders / Transverse Beams	N/A	N/A	N/A	N/A	Not applicable to this structure.
12	Riverbed	1	Y	26 36	Y	Riverbed was generally in good condition. Immediately upstream and downstream of the bridge, vegetation build-up is restricting the channel capacity. Silt build-up was noticed in the north and south spans. See Figure 5 and Figure 6 in Appendix A.
13	Other Elements	0	Y	12 35 38	Y	Vertical steel strips are visible in the end elevation of all portal legs which are now heavily rusted. Their purpose is unknown. Concrete cover of the steel strip on the north abutment has spalled from the surface. See Figure 11, Figure 12 and Figure 34 in Appendix A.

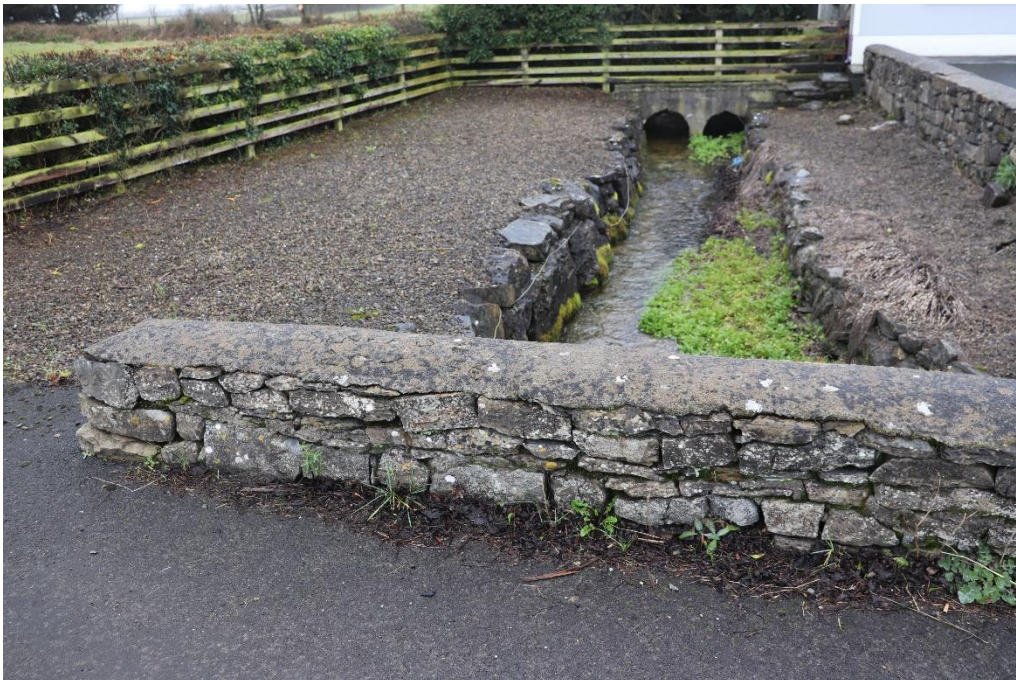
Figure 38 – West Parapet

Component No.	Component	Condition Rating	Maintenance Required	Defect Type	Photos	Comments
4	Parapet/safety Barrier	0	N	26	Y	Inspection of parapets was undertaken from the bridge deck. Heavy vegetation was present over the northern portion of the east parapet. If left unmaintained could damage the masonry facing. No major defects were noted to the parapets over the structure, see Figure 38 and Figure 39 in Appendix B for general condition. However, the west parapet height (450mm) is too low for pedestrians and should be increased to 1.25m in accordance with DN-REQ-03034, The Design of Road Restraint Systems (Vehicle and Pedestrian) for Roads and Bridges.
5	Embankments / Revetments	0	N	26	N	No defects noted to the east or west embankment or revetments of the structure, however, access to the east embankment was limited due to the excessive vegetation.
6	Wingwalls / Spandrel Walls / Retaining Walls	2	N	26	Y	Wing walls of the structure were found to be in good condition with some vegetation growth, see Figure 40 and Figure 48 in Appendix B. Access to the wingwalls on the east was limited due to excessive vegetation.

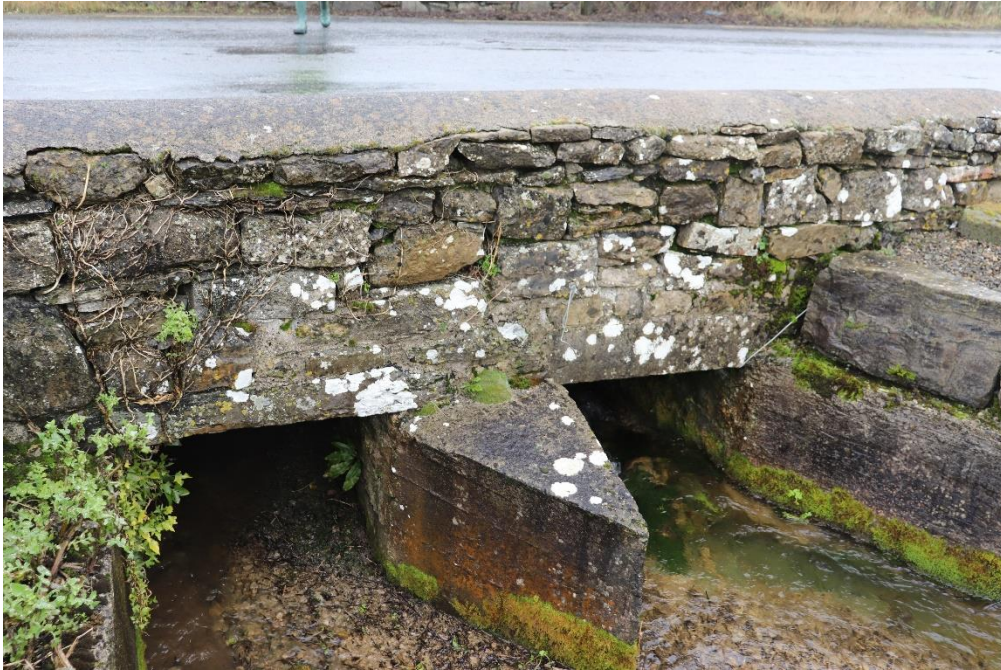
**Figure 41 – Central Pier**

7	Abutments	2	N	26	Y	Abutments to the structure were found to be in good condition with some vegetation growth, see Figure 40 and Figure 48 in Appendix B. Access to the abutments on the east was limited due to excessive vegetation.
8	Piers	0	N	-	Y	Central Pier was found to be in good condition with no defects noted, see Figure 41 in Appendix B.
9	Bearings	N/A	N/A	N/A	N/A	Not applicable to this structure.
10	Deck/Slab	0	N	-	N	No defects noted to the deck soffit of the structure. Due to the limited clearance within the structure, <1m, inspection of the soffit was not possible.
11	Beams / Girders / Transverse Beams	0	N	-	Y	Transverse capping stones and beams were found to be in good condition with no defects noted. See Figure 42 and Figure 44 in Appendix B.
12	Riverbed	2	Y	26 36	Y	Debris and silt build-up on the northeast of the structure. Otherwise, the riverbed is in good condition. See Figure 46 and Figure 49 in Appendix B.
